UNDERWATER BRIDGE INSPECTION REPORT

STRUCTURE NO. 93280
CR NO. 119
OVER THE
EAST BRANCH OF THE RAT ROOT RIVER
DISTRICT 1 - KOOCHICHING COUNTY

PREPARED FOR THE
MINNESOTA DEPARTMENT OF TRANSPORTATION
BY
COLLINS ENGINEERS, INC.
JOB NO. 3512(CEI 15)

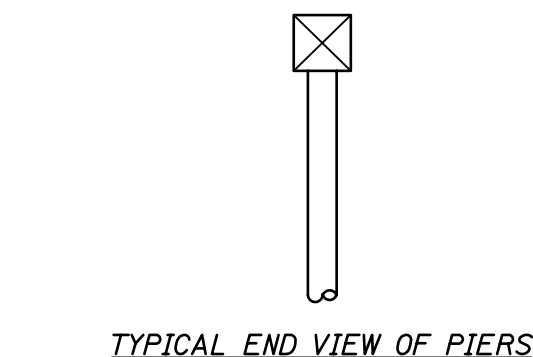
TYPICAL END VIEW OF PIERS

- Light accumulation of timber debris at Piles 1, 2, and 5, up to 6 inches diameter pieces, typically extending 3 feet above channel bottom.
- Light accumulation of timber debris at Piles 2 and 5, up to 6 inches diameter pieces, typically extending 3 feet above channel bottom.

- Escaping fill was observed at 1 inch gap in horizontal planking, 4 feet above mudline, with 3 inches maximum penetration.
- Escaping fill was observed at 1 inch gap in horizontal planking, 3 feet above mudline, with 3 inches maximum penetration.
